NIST NCSTAR 1-5A

Federal Building and Fire Safety Investigation of the World Trade Center Disaster

Visual Evidence, Damage Estimates, And Timeline Analysis

(Chapter 9 - Appendix C)

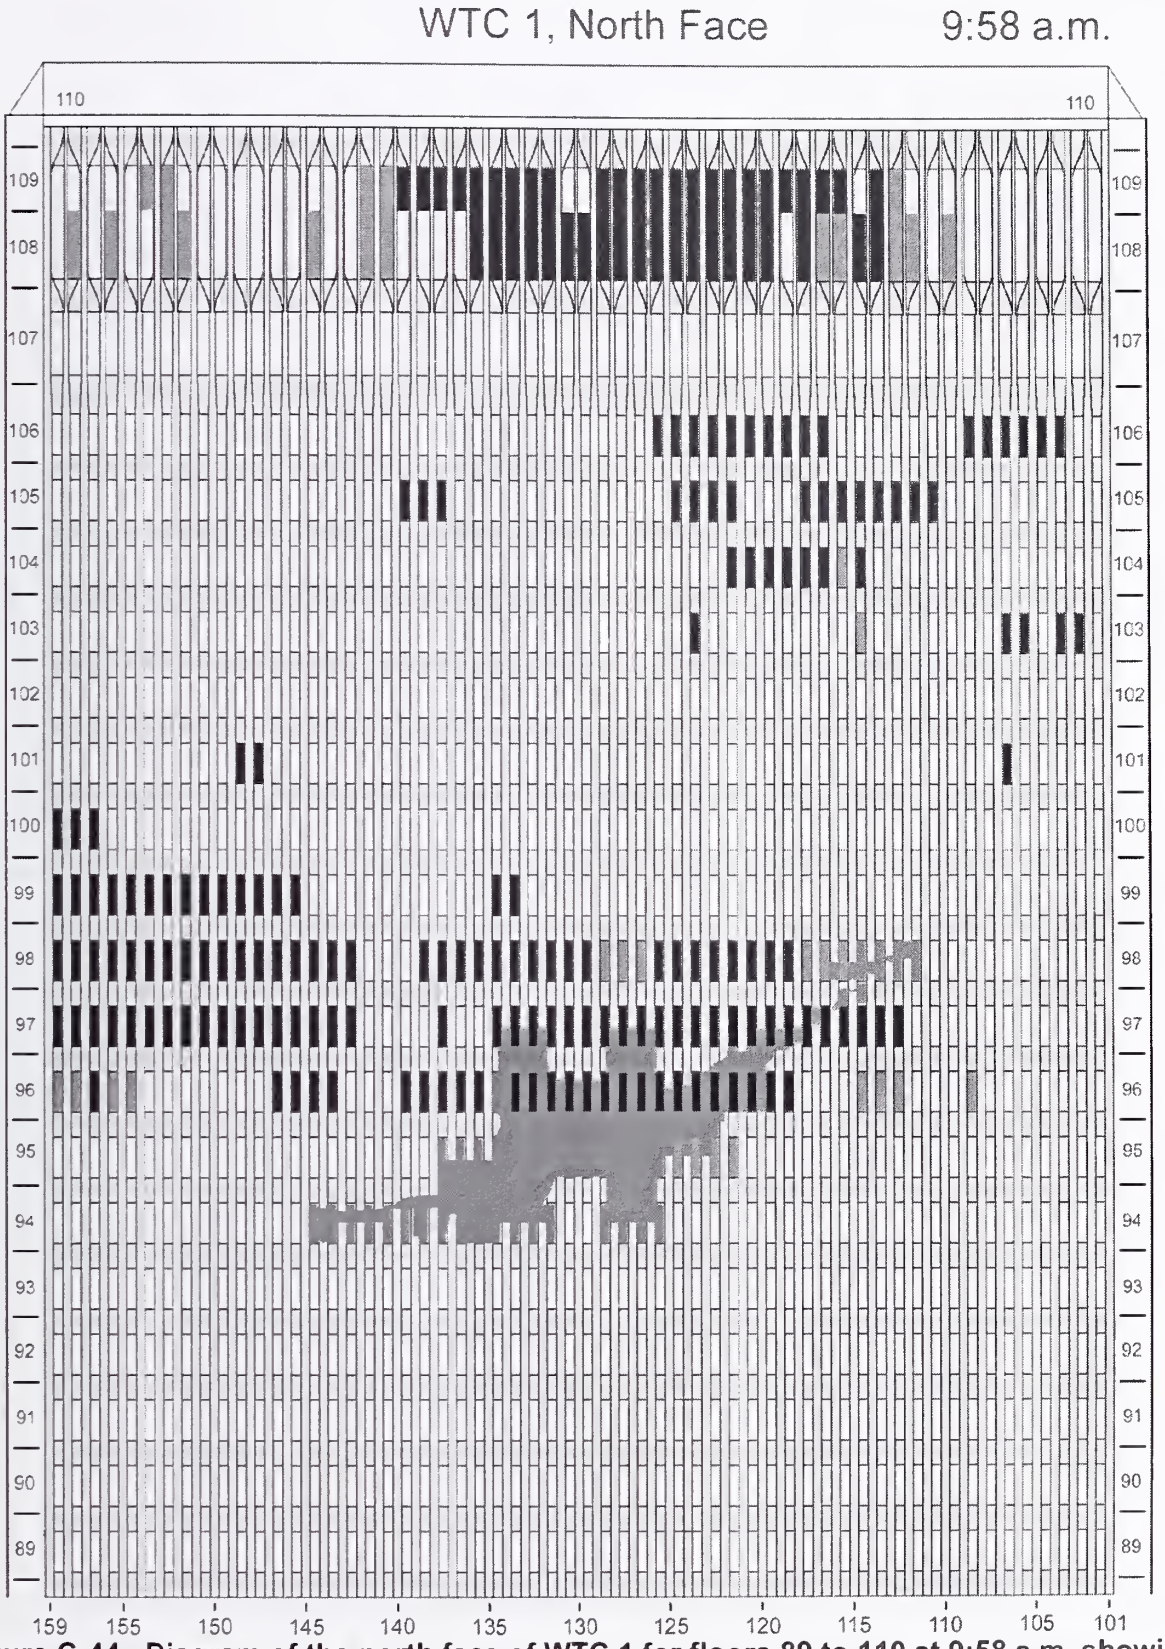
Figure C-44. Diagram of the north face of WTC 1 for floors 89 to 110 at 9:58 a.m. showing windows where smoke was observed and those that were hidden from view.

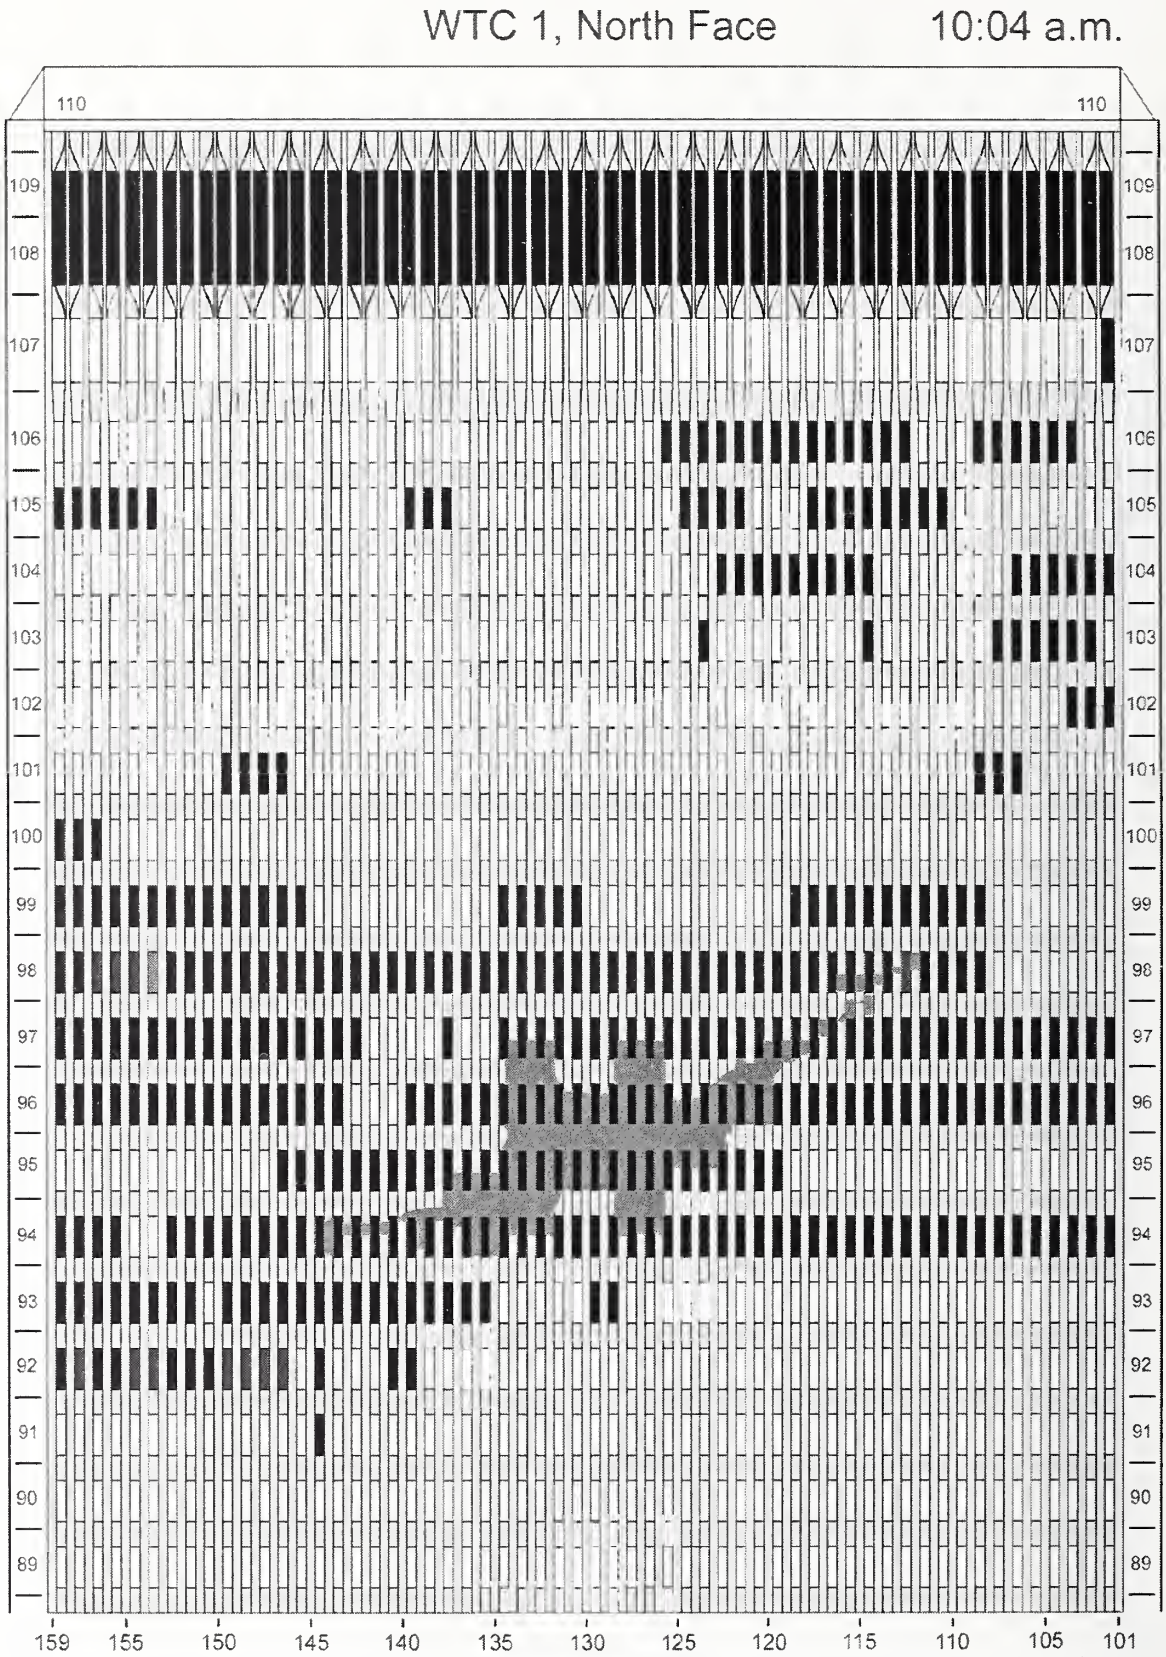
Figure C-45. Diagram of the north face of WTC 1 for floors 89 to 110 at 10:04 a.m. showing the condition of windows and locations of fires.

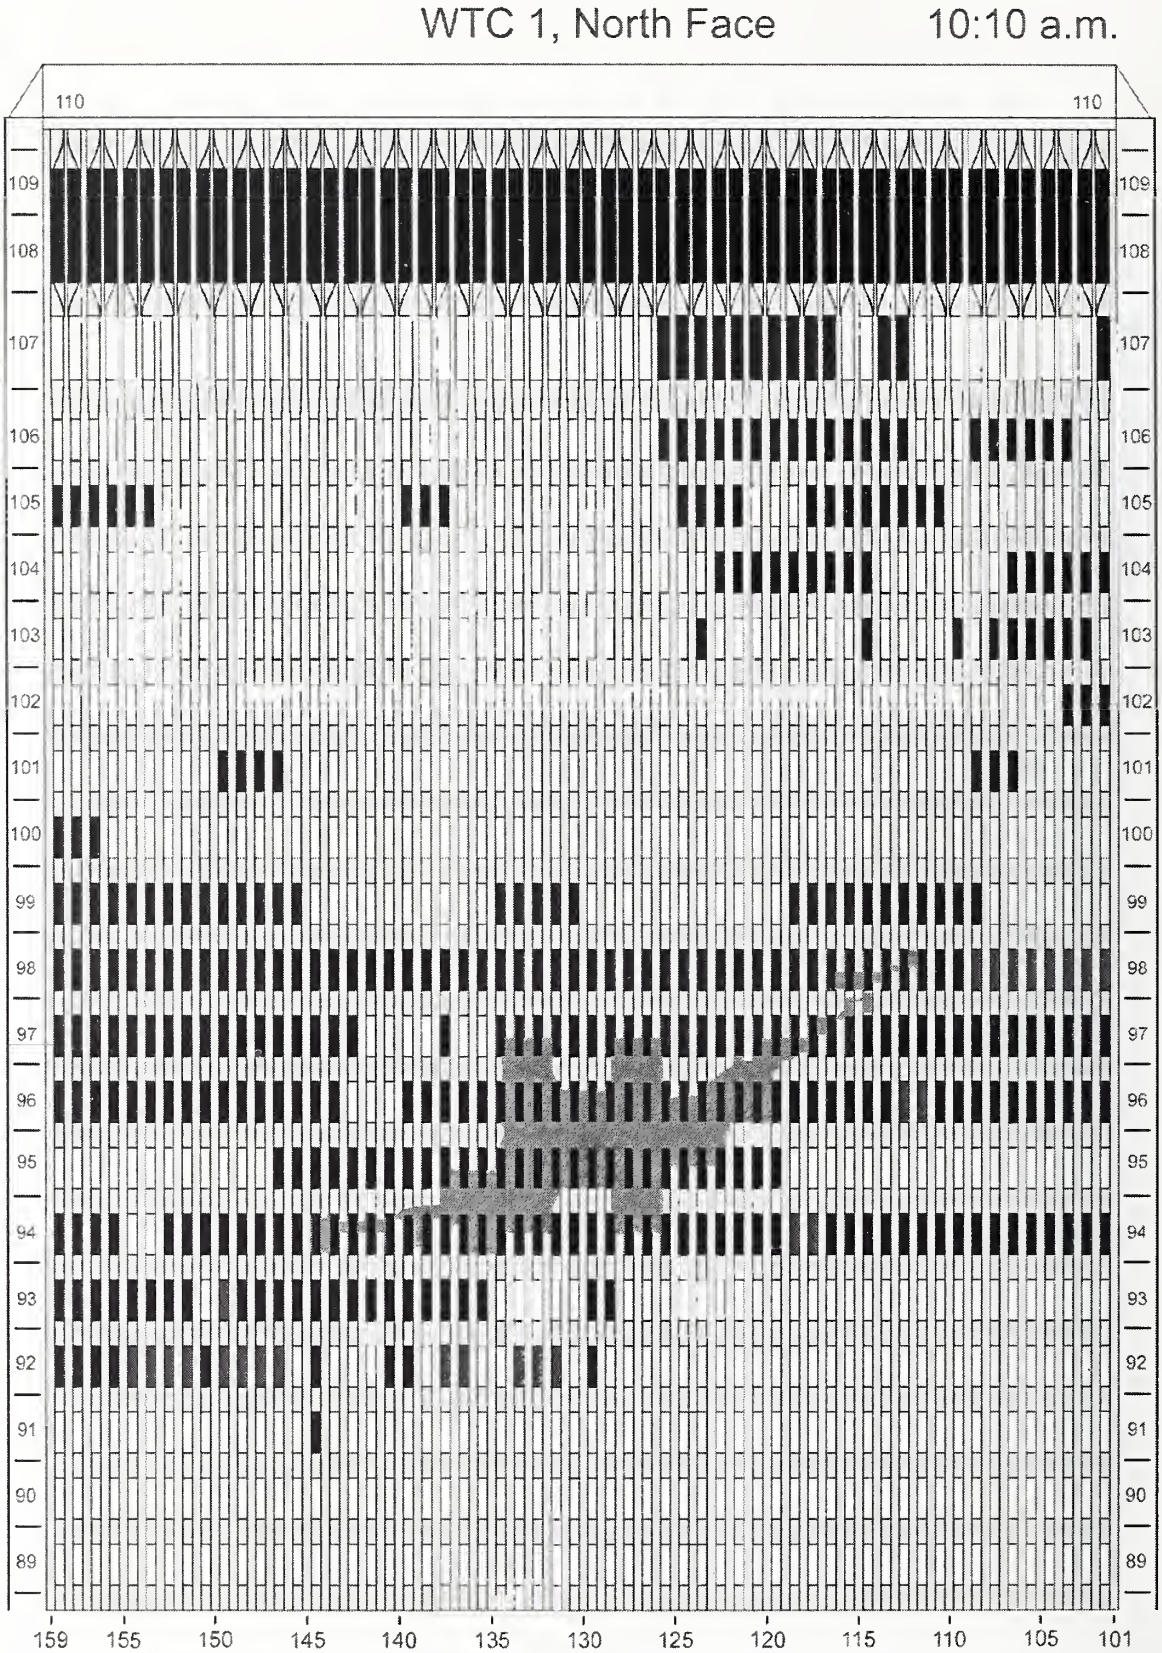
Figure C-47. Diagram of the north face of WTC 1 for floors 89 to 110 at 10:10 a.m. showing the condition of windows and locations of fires.

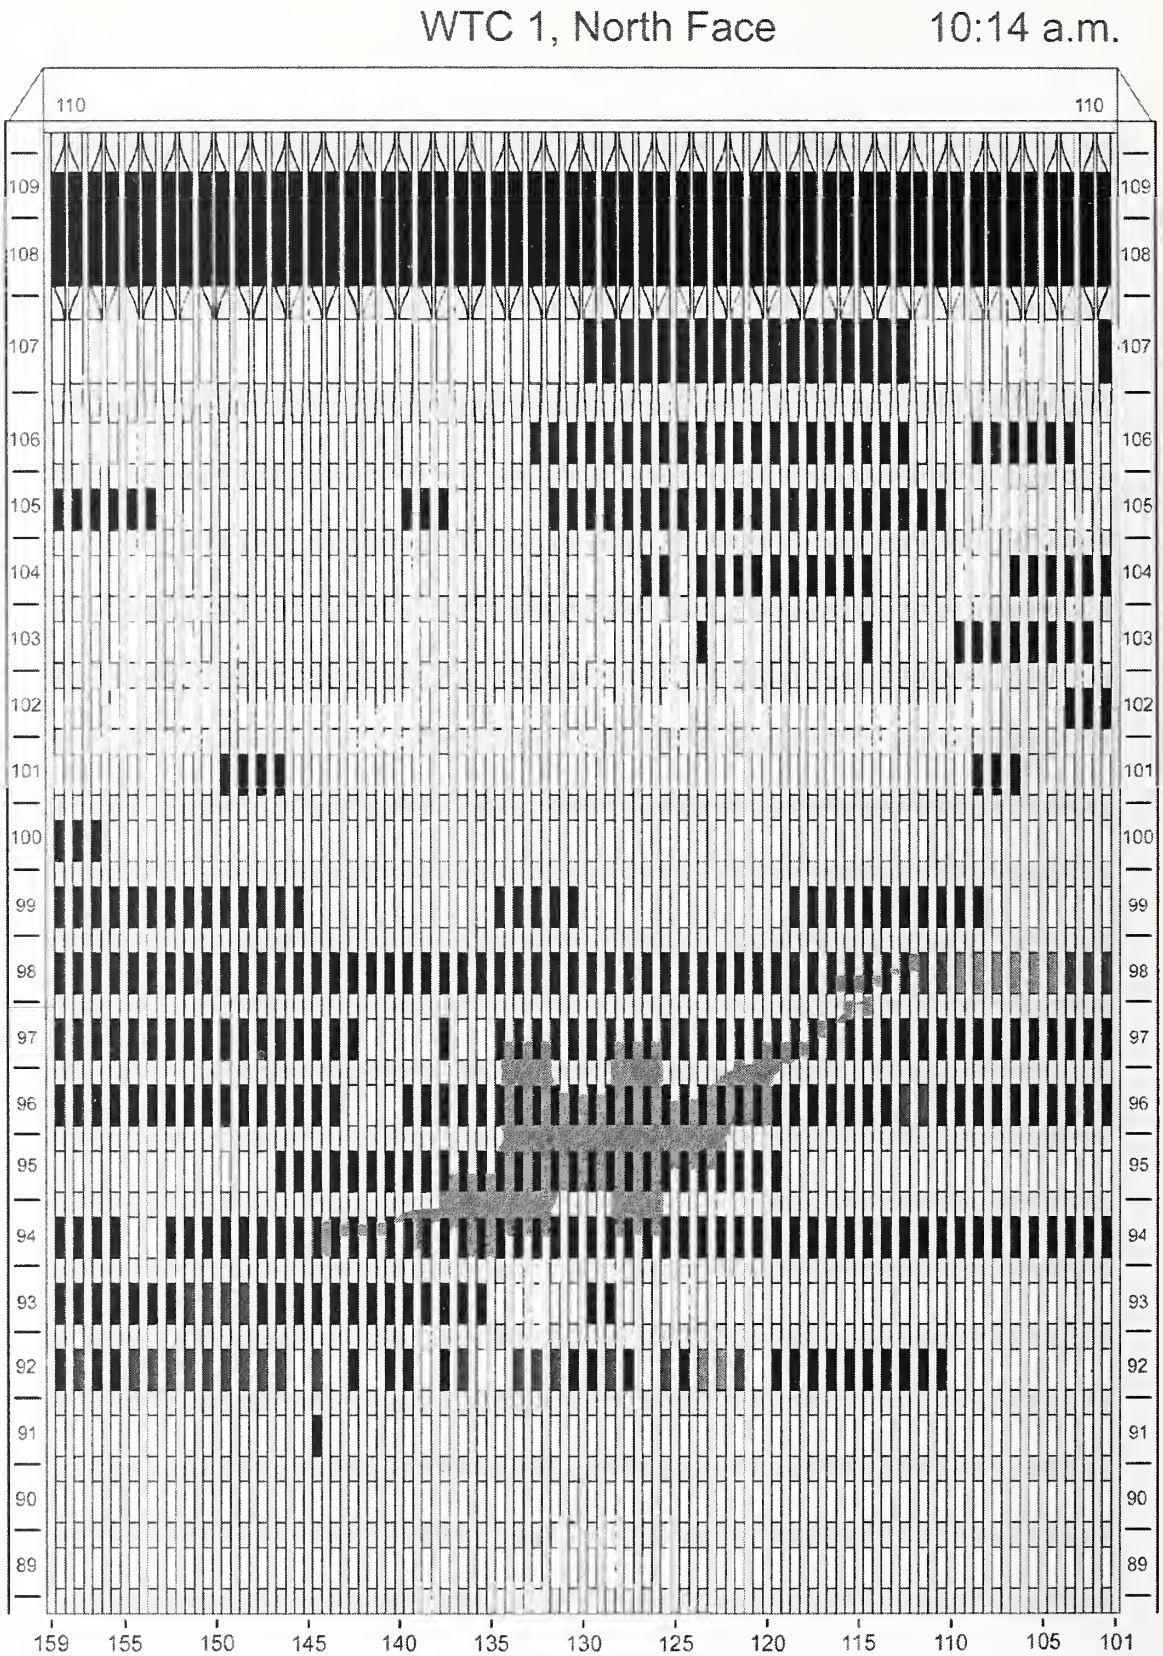
Figure C-49. Diagram of the north face of WTC 1 for floors 89 to 110 at 10:14 a.m. showing the condition of windows and locations of fires.

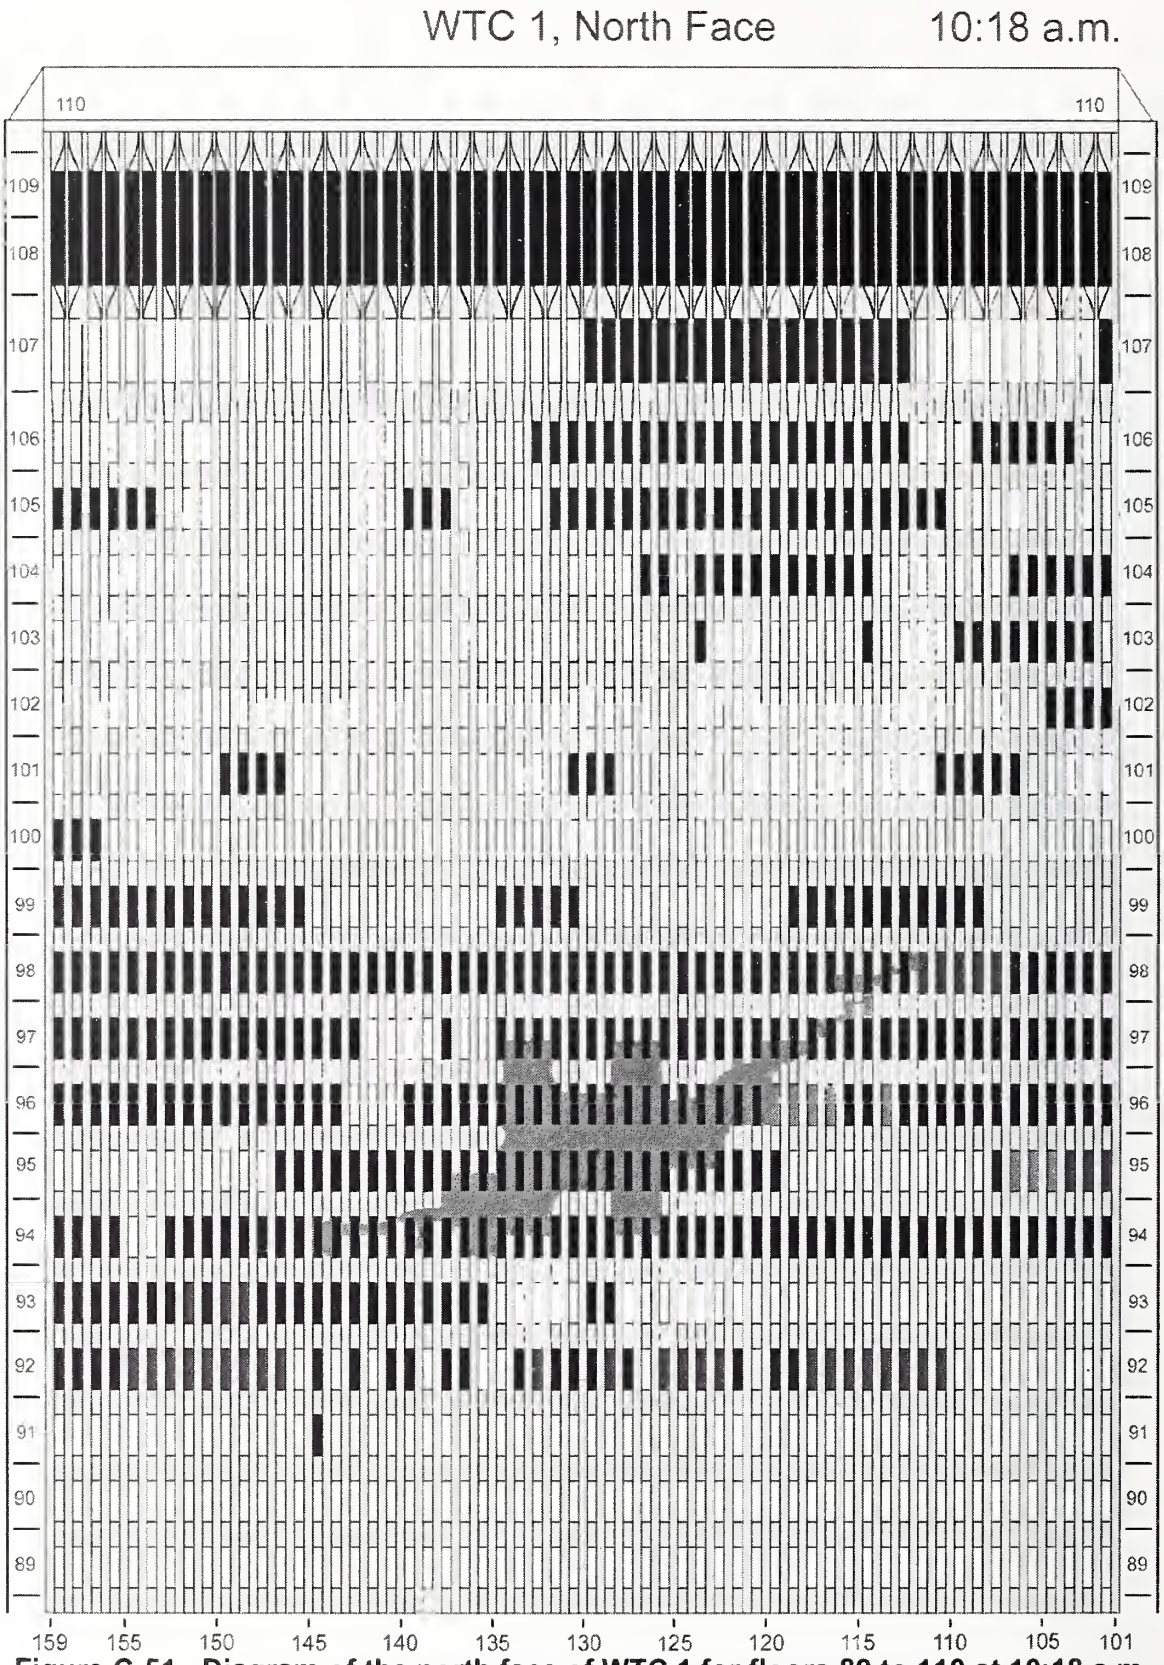
Figure C-51. Diagram of the north face of WTC 1 for floors 89 to 110 at 10:18 a.m. showing the condition of windows and locations of fires.

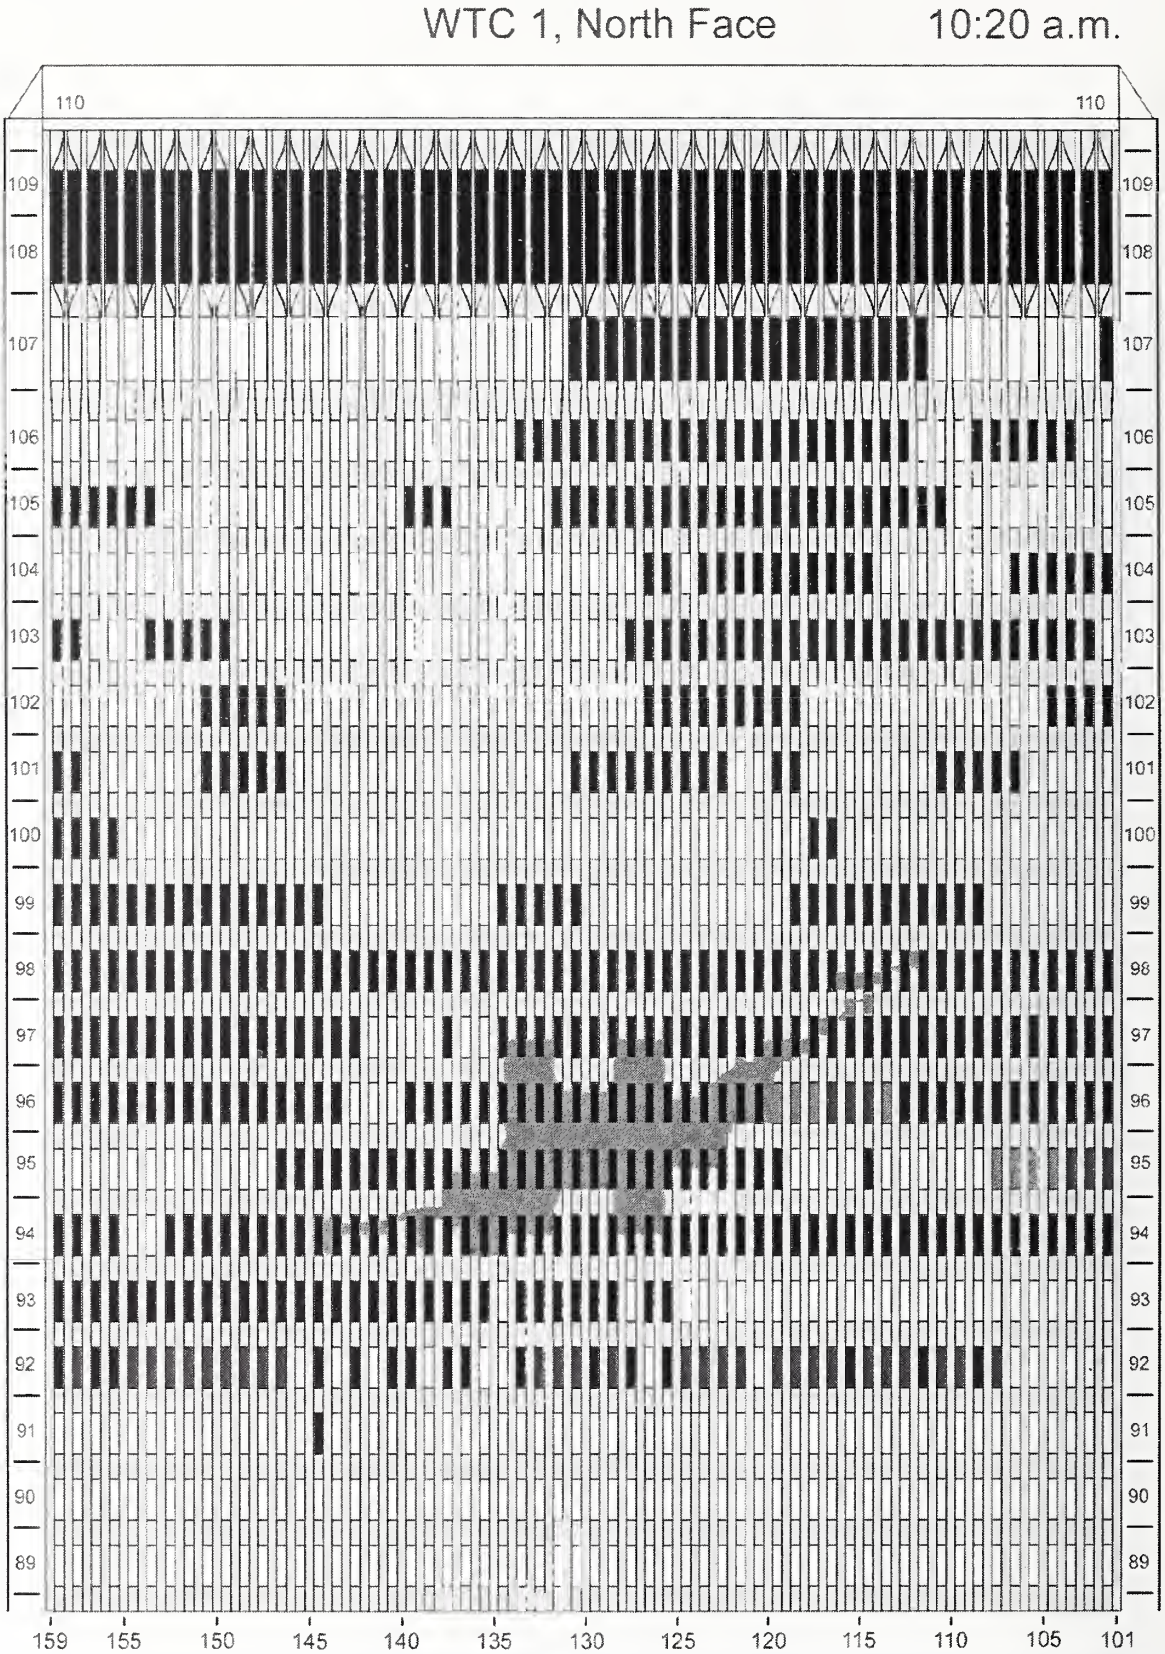
Figure C-53. Diagram of the north face of WTC 1 for floors 89 to 110 at 10:20 a.m. showing the condition of windows and locations of fires.

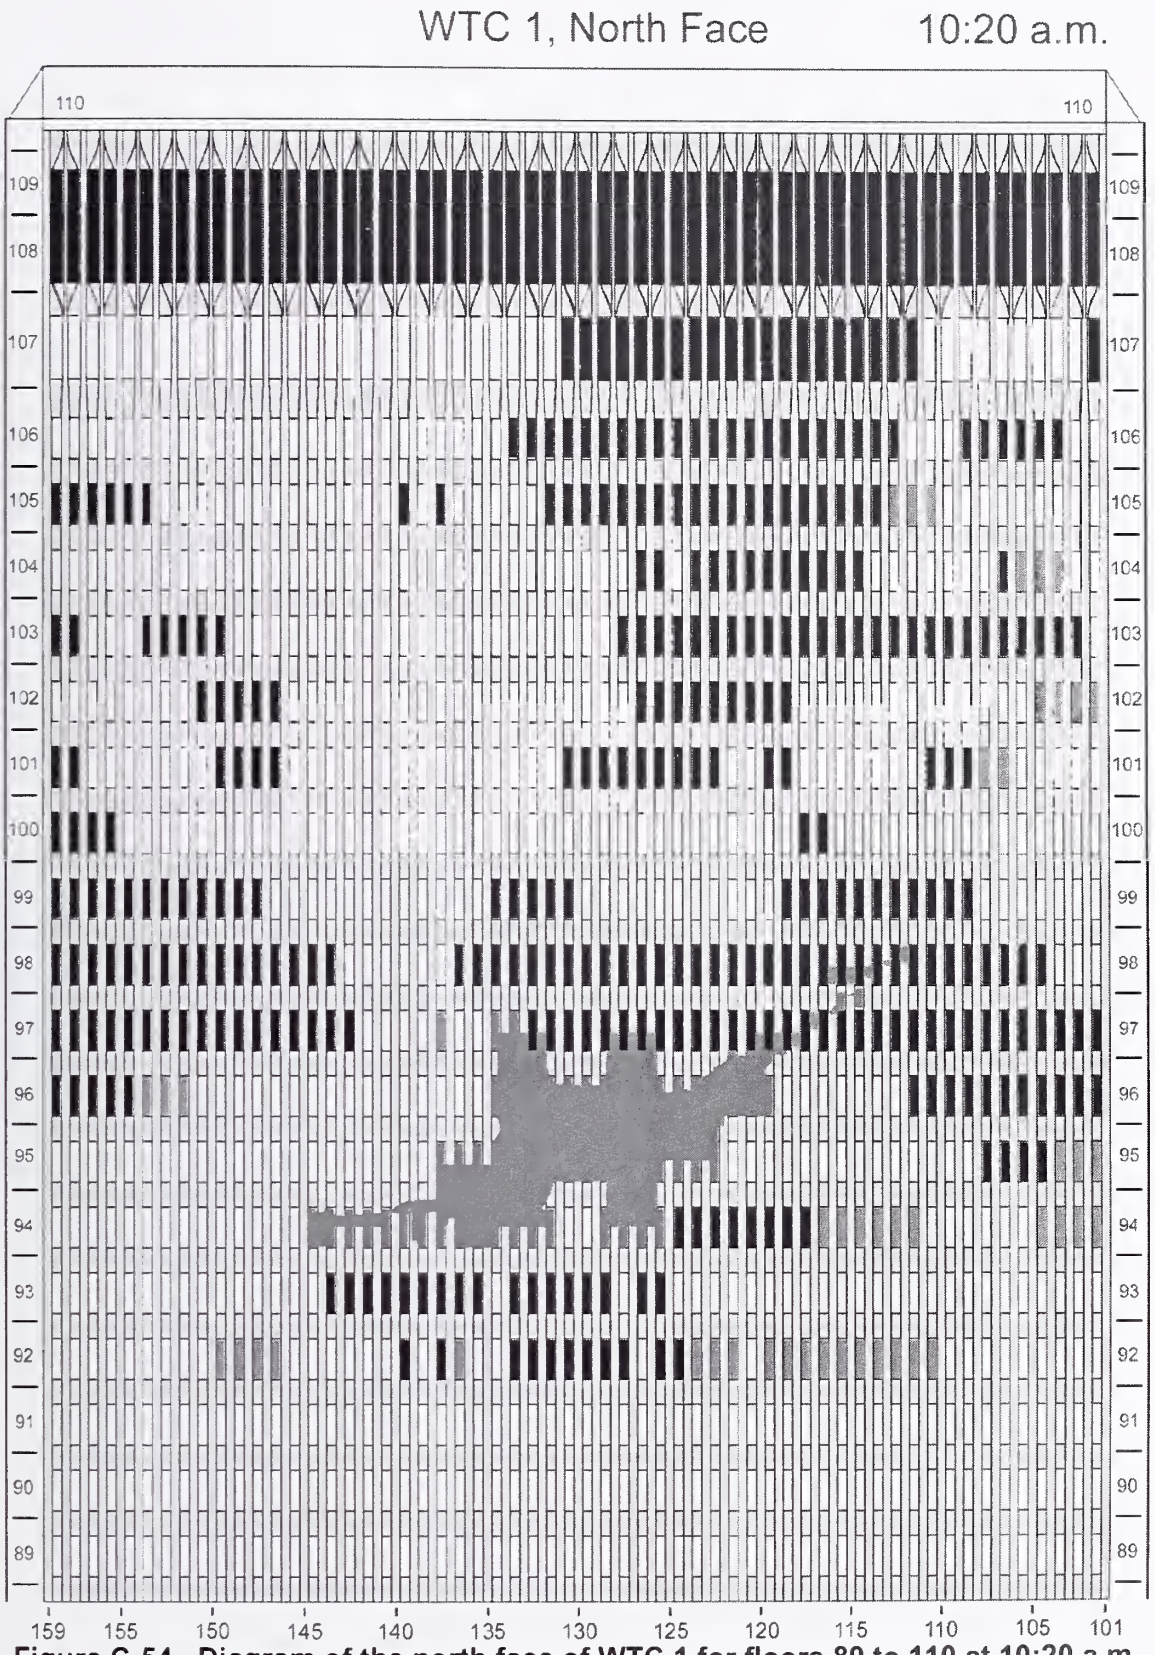
Figure C-54. Diagram of the north face of WTC 1 for floors 89 to 110 at 10:20 a.m. showing windows where smoke was observed and those that were hidden from view.

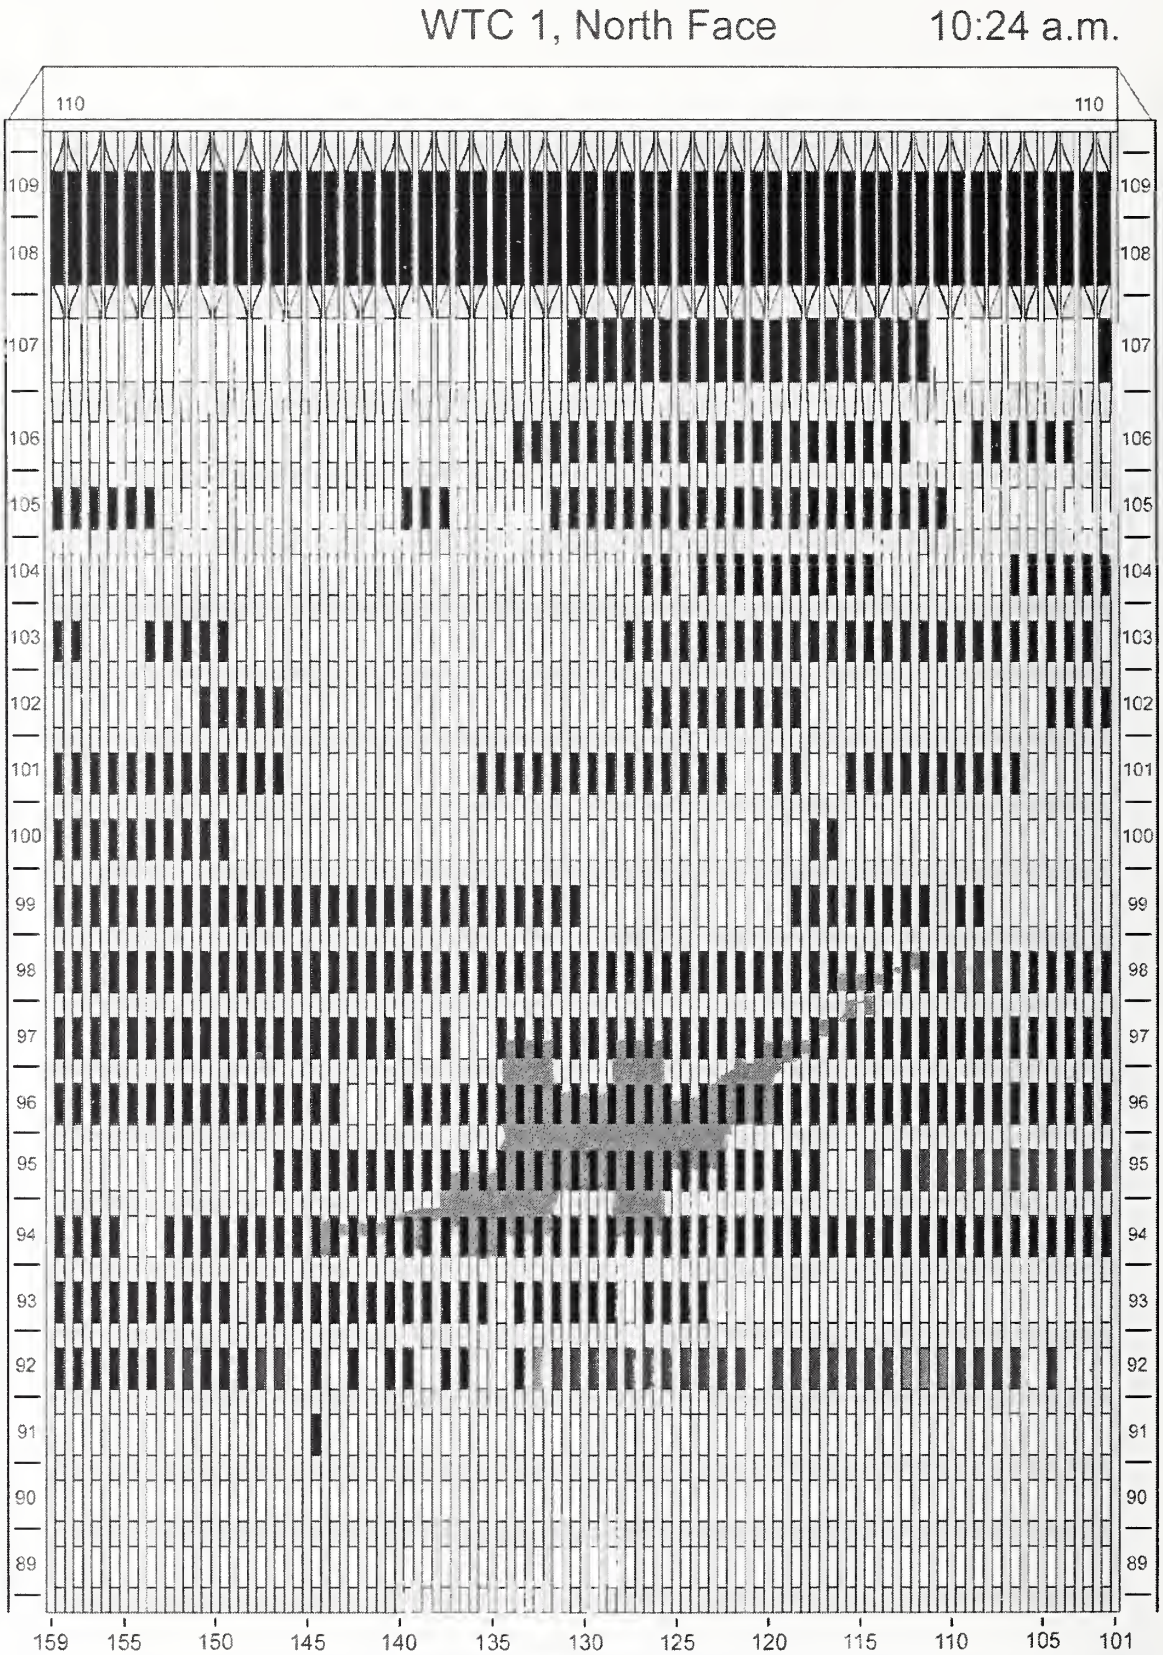
Figure C-55. Diagram of the north face of WTC 1 for floors 89 to 110 at 10:24 a.m. showing the condition of windows and locations of fires.

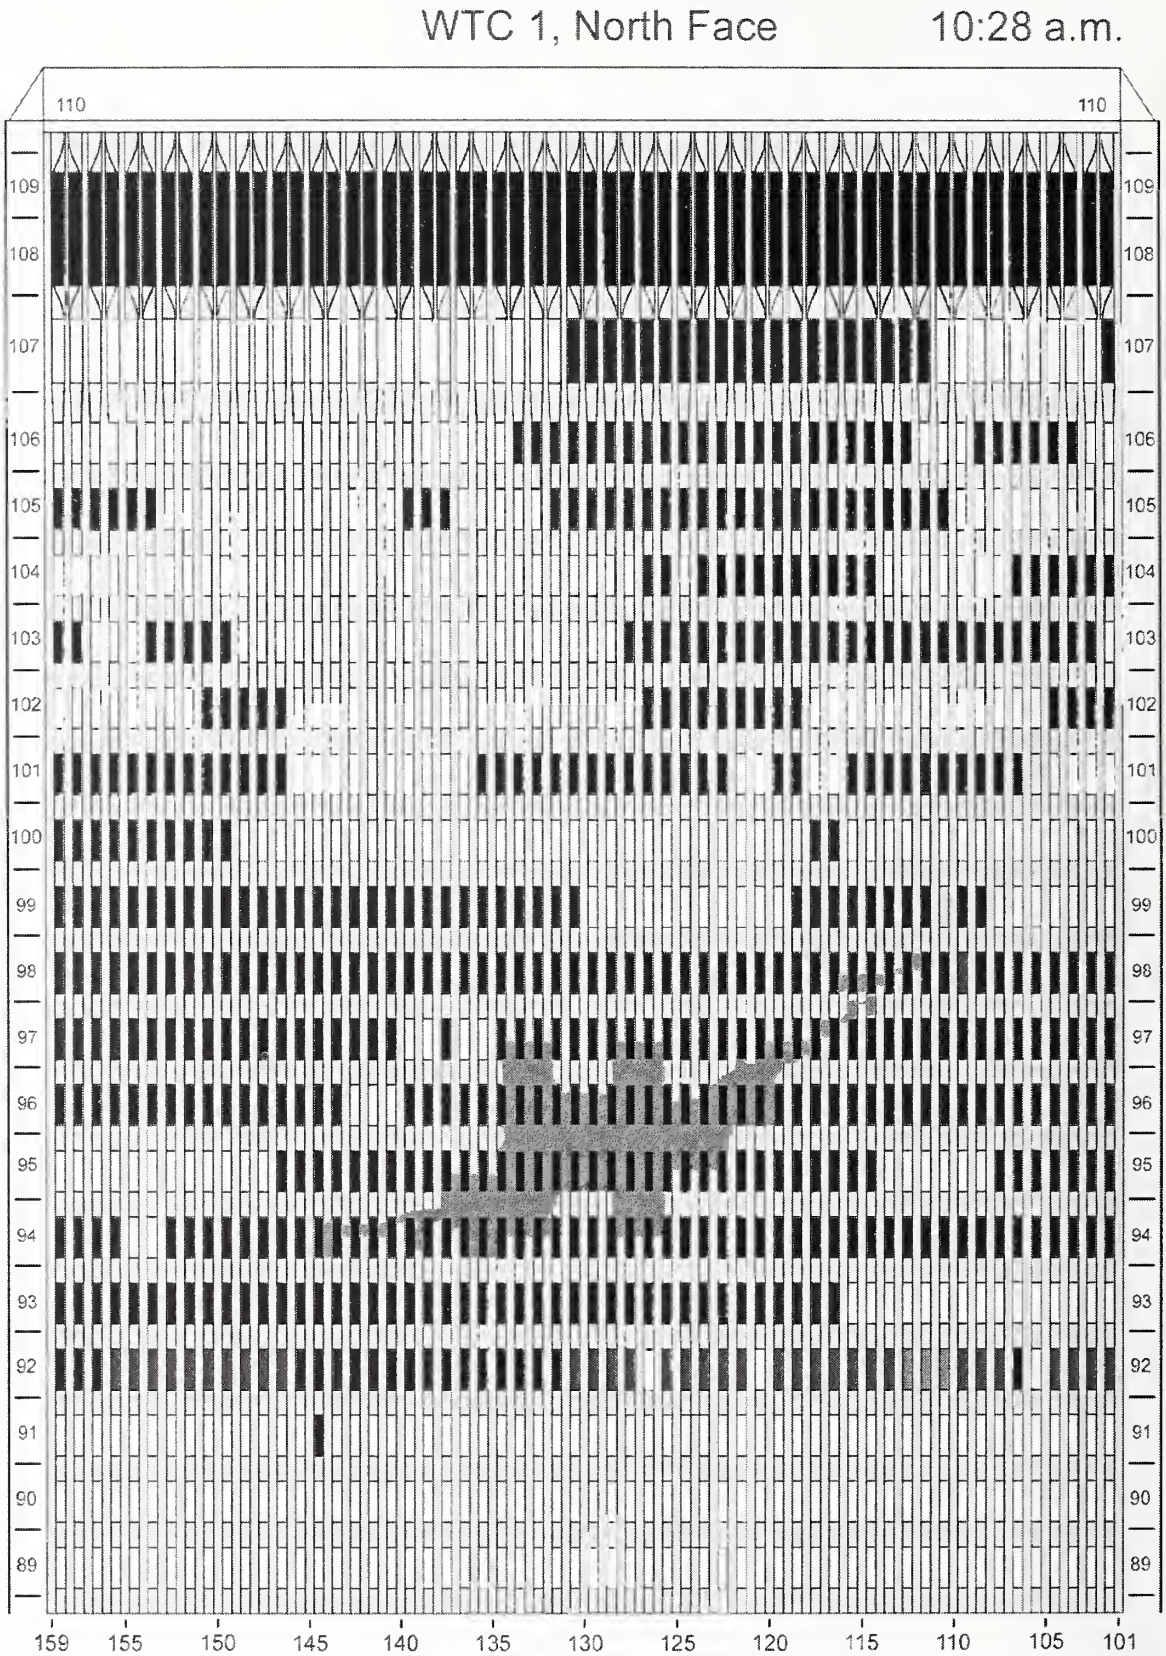
Figure C-57. Diagram of the north face of WTC 1 for floors 89 to 110 at 10:28 a.m. showing the condition of windows and locations of fires.

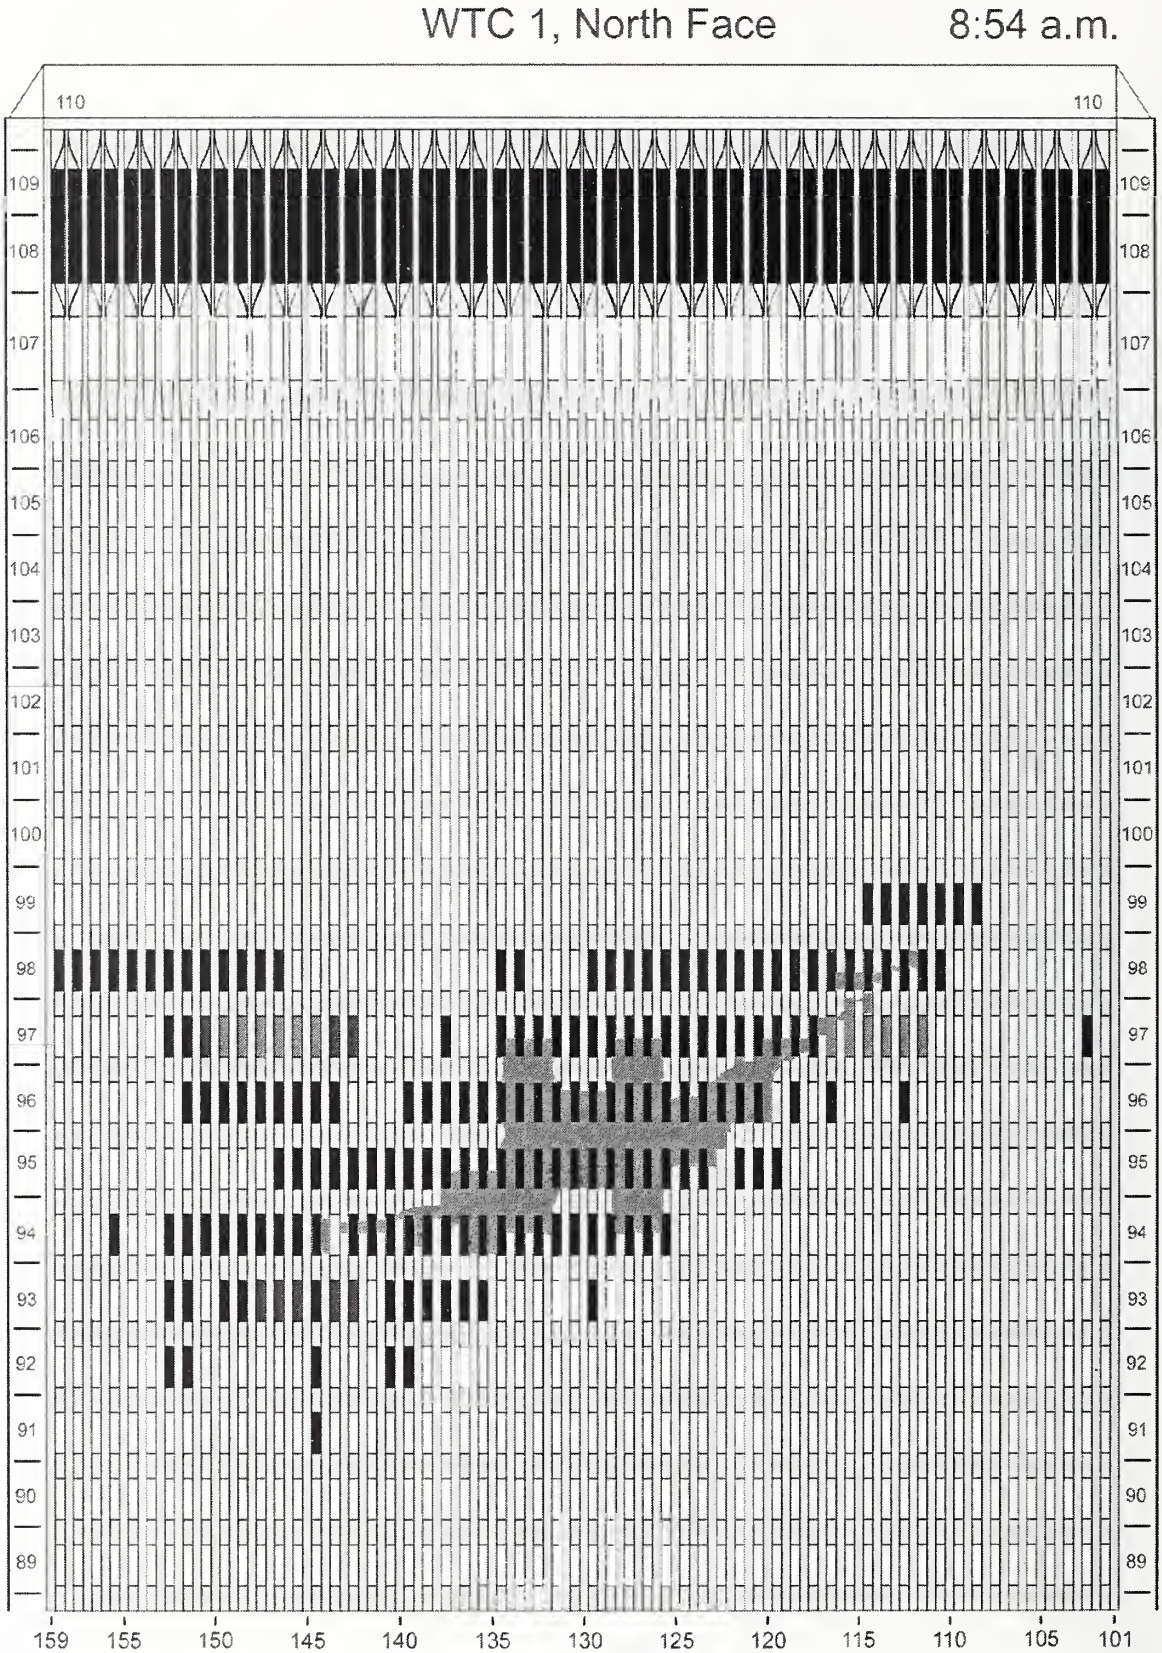
Figure C-9. Diagram of the north face of WTC 1 for floors 89 to 110 at 8:54 a.m. showing the condition of windows and locations of fires.

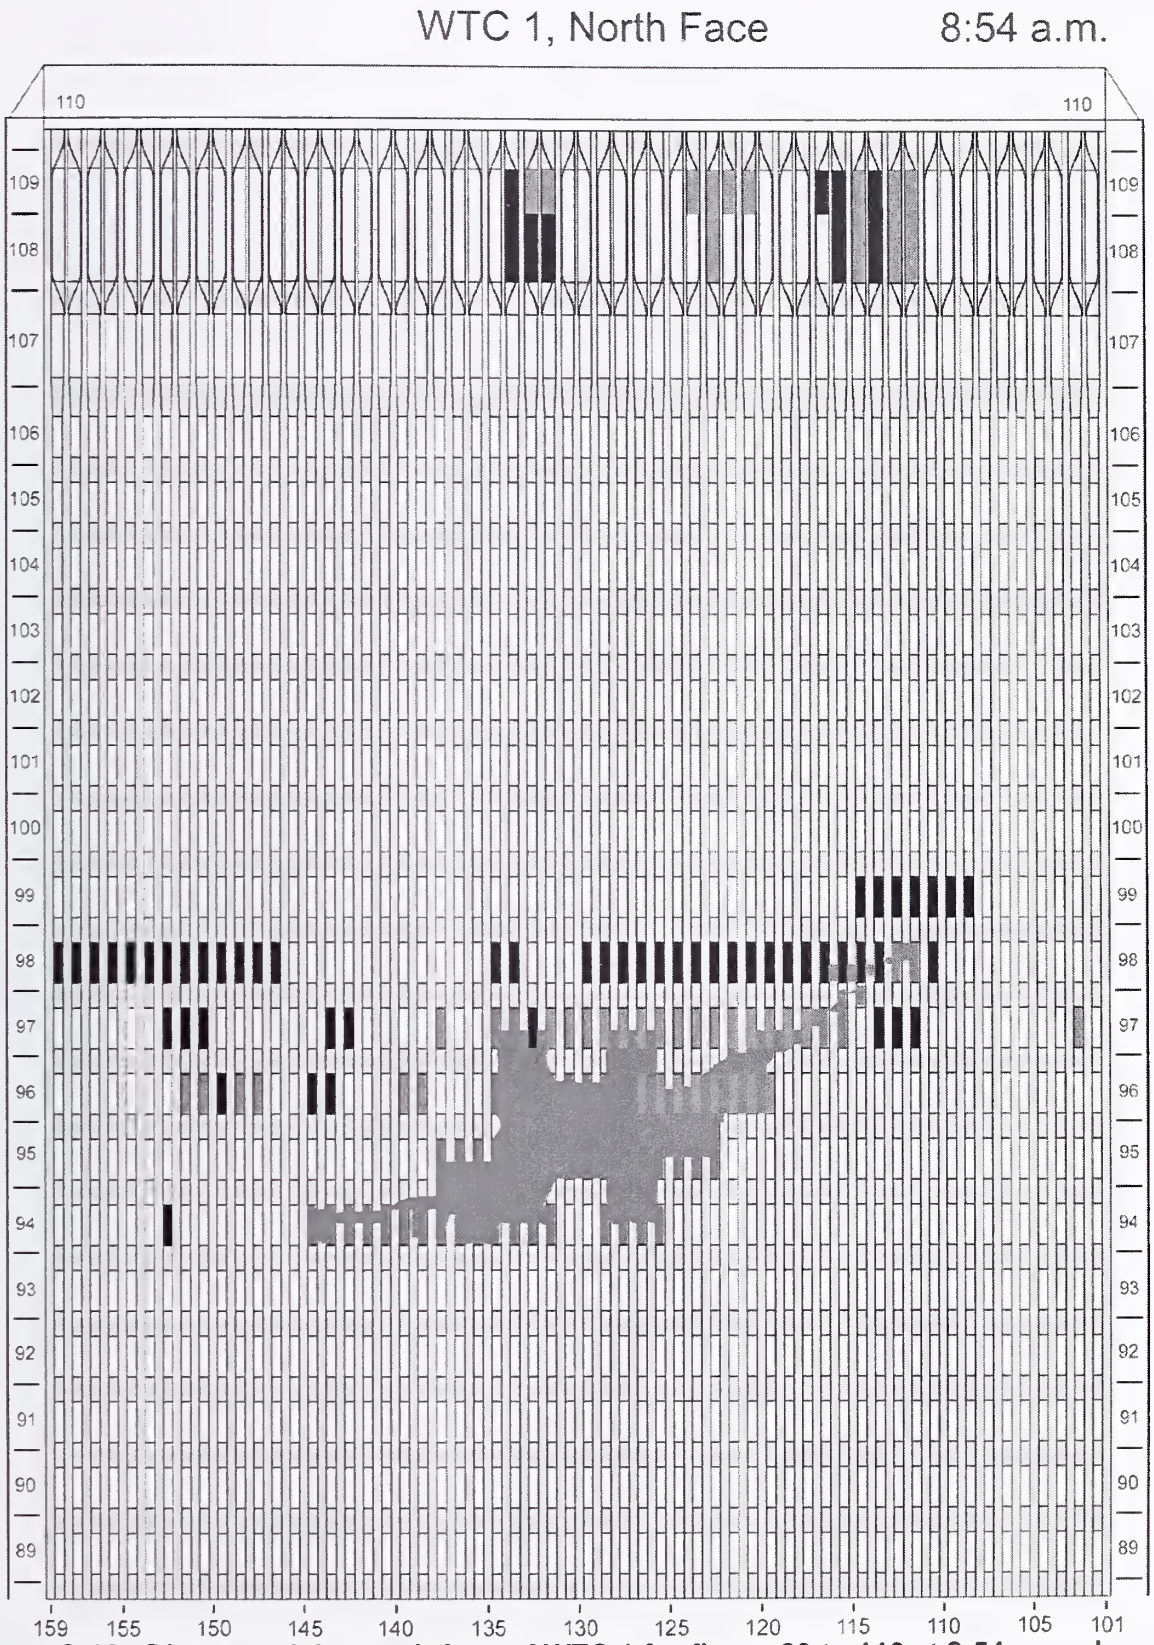
Figure C-10. Diagram of the north face of WTC 1 for floors 89 to 110 at 8:54 a.m. showing windows where smoke was observed and those that were hidden from view.
